National Register of Historic Places
Registration Form

historic name Boyden Block

street & town 2 South Main Street ☐ not for publication

city or town Coalville ☐ vicinity

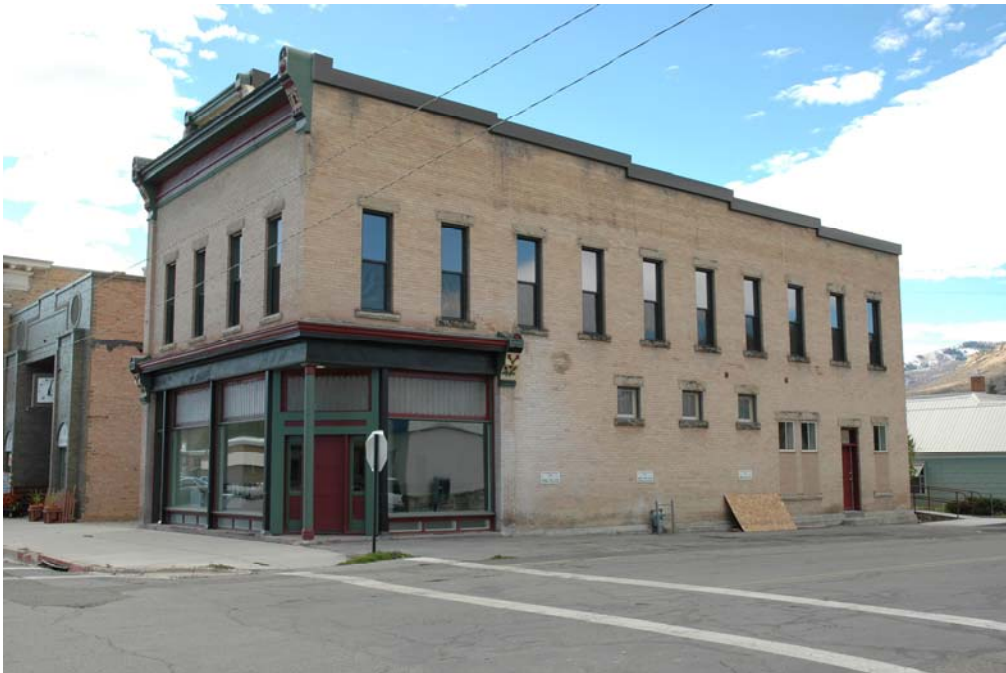
Photo No. 1:

6. East and north elevations of building. Camera facing southwest.

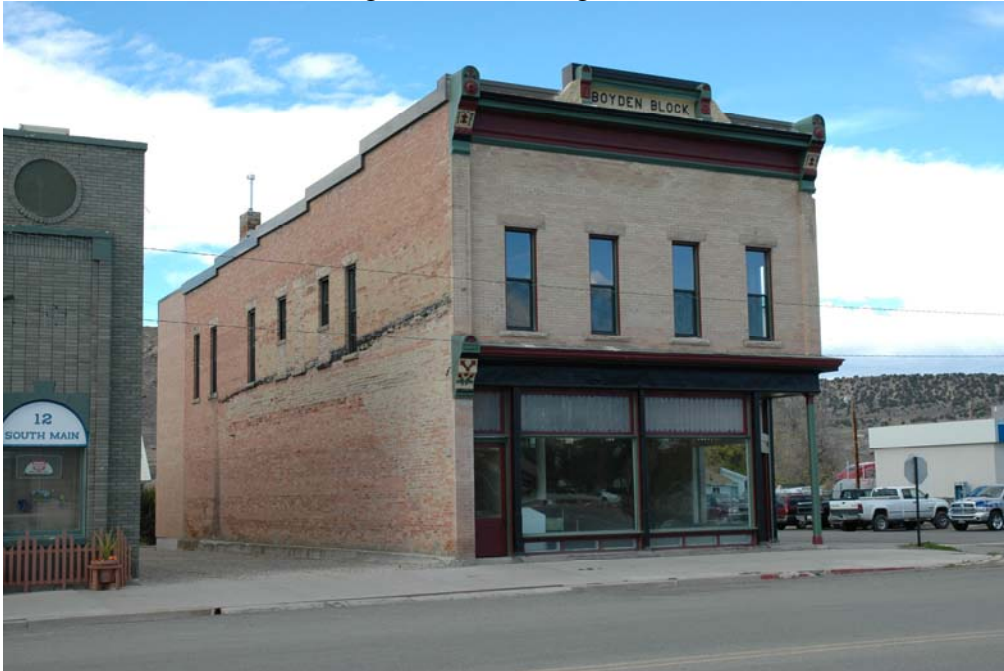
Photo No. 2:

6. East and south elevations of building. Camera facing west.

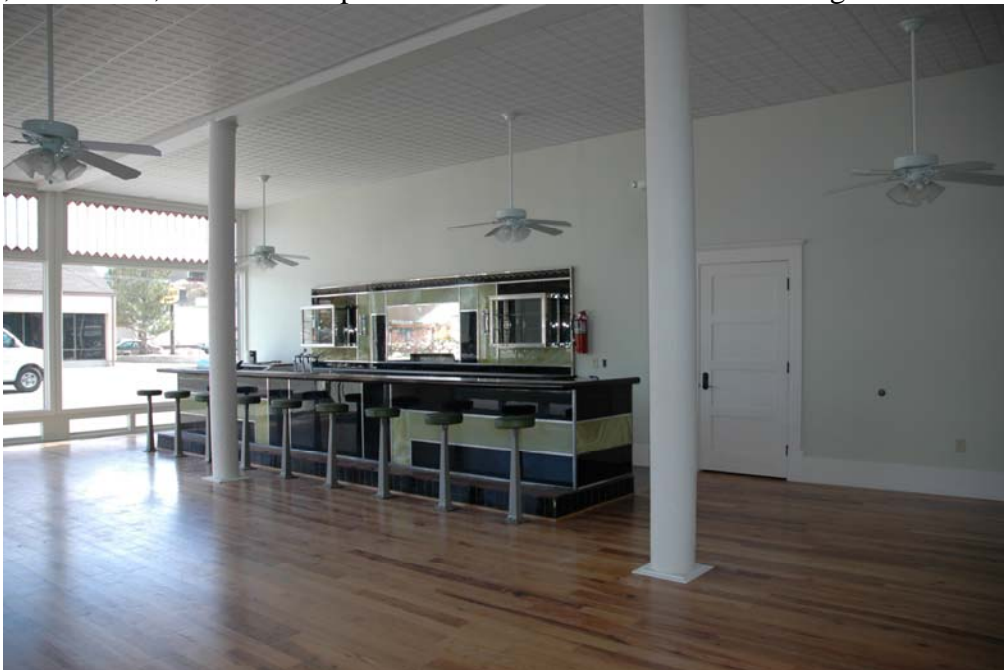
Photo No. 3:

6. Interior, main floor, commercial space and soda fountain. Camera facing southeast.

The interior finishes have been replaced and the false ceiling removed. The soda fountain is in the process of restoration. New restrooms and a mechanical room were added to the south wall. In the rear portion, the bathroom was removed and the historic spaces rehabilitated. The second floor was also rehabilitated. With the exception of the wide opening between the front offices (the original opening with pocket doors were covered at an unknown date), all woodwork (casings, baseboards, newel posts, etc.) is original. The front portion is divided into four office spaces. One of the four was divided into a break room and restroom. The rear half of the second floor is one large open space. The basement is fully excavated though unfinished except for a concrete floor and the new stair access in the rear addition. The attic space is quite extensive due to the roof construction, but is unfinished.

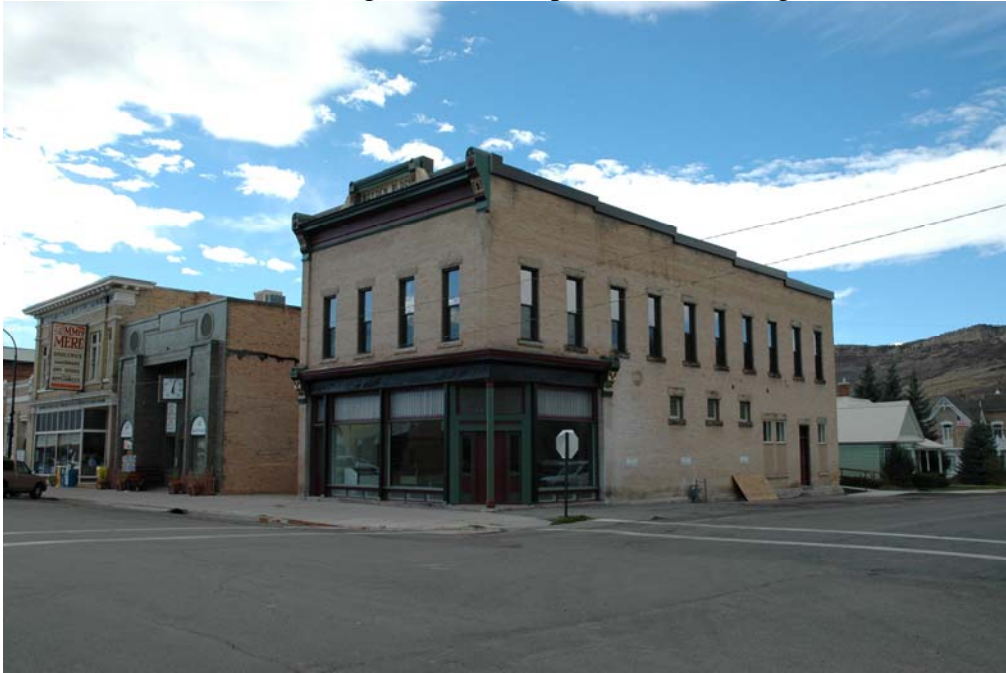
Photo No. 4:

6. East and north elevations of building and streetscape. Camera facing southwest.

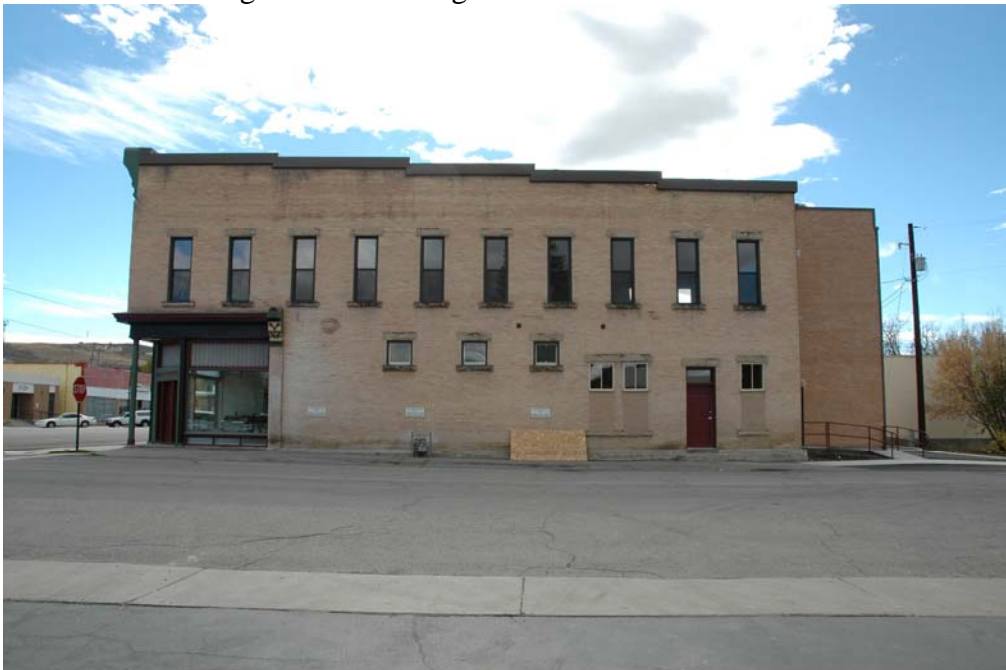
Photo No. 5:

6. North elevation of building. Camera facing south.

There are three small, square windows on the north elevation that provide light to the retail space. These are original and feature glass similar to the storefront transoms. With the exception of the storefront, all windows on the building feature flat, rock-faced sandstone lintels and sills. Most of the original windows in the building were tall and narrow with one-over-one, double hung, wood sash. Three windows on the main floor (north elevation to light the backroom) were replaced with shorter two-pane fixed windows in the 1980s (for security reasons) and the bottom of the space filled with brick. There smaller windows have been retained and rehabilitated. The second floor features four tall windows on the façade, ten on the north elevation, two on the west elevation, and seven openings to the south. Two windows were shortened on the south elevation and one partially filled in with brick (circa 1960s). In 1995, the original second floor windows, which were in poor condition, were replaced with aluminum windows. The new double-hung windows replicate the original one-over-one windows and have been retained in the recent rehabilitation. They are dark brown in color and do not detract from the building's historic integrity. The smaller windows were also replaced. The original brick parapet is capped with aluminum similar in color to the second floor windows (also 1990s). A new roof and drainage system was installed when the roof was replaced.

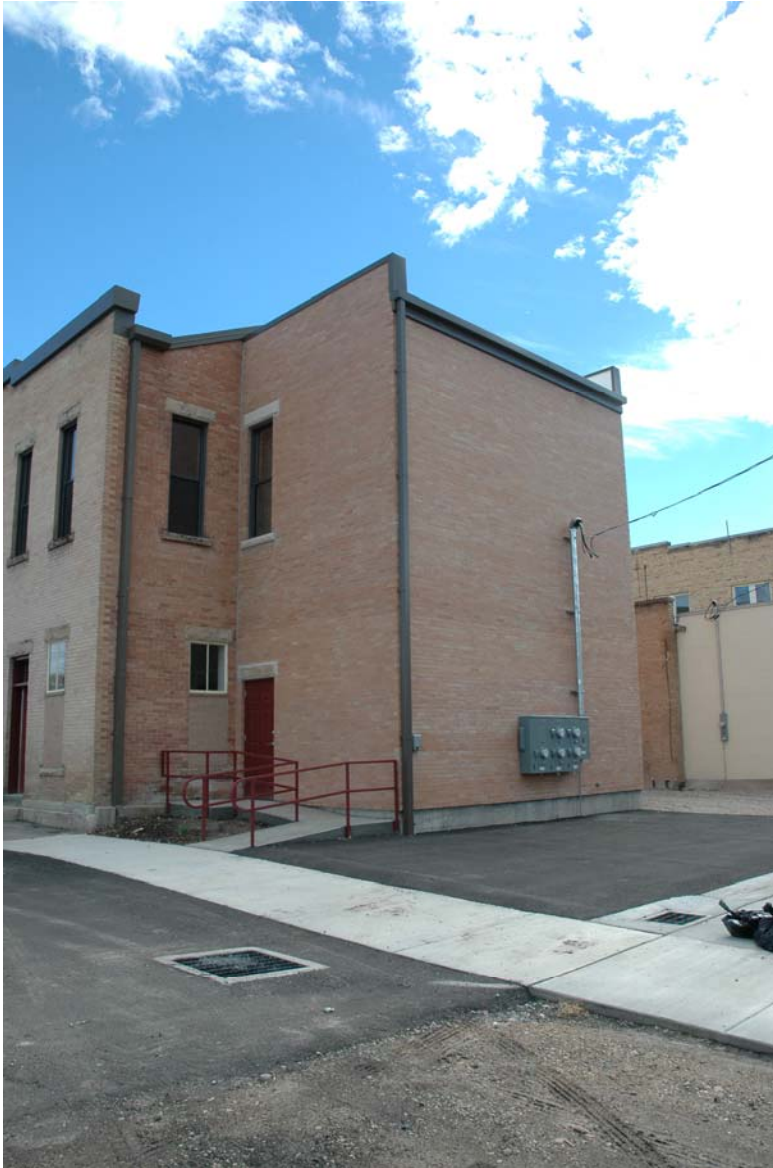
Photo No. 6:

6. North and west elevations of building and annex. Camera facing southeast.

The rehabilitation included the construction of a two-story brick addition on a concrete foundation at the rear of the building to house an elevator and staircase. The new wing was built on the approximate footprint of an exterior staircase and veranda that was on the building in the 1920s (date of demolition unknown). On the rear

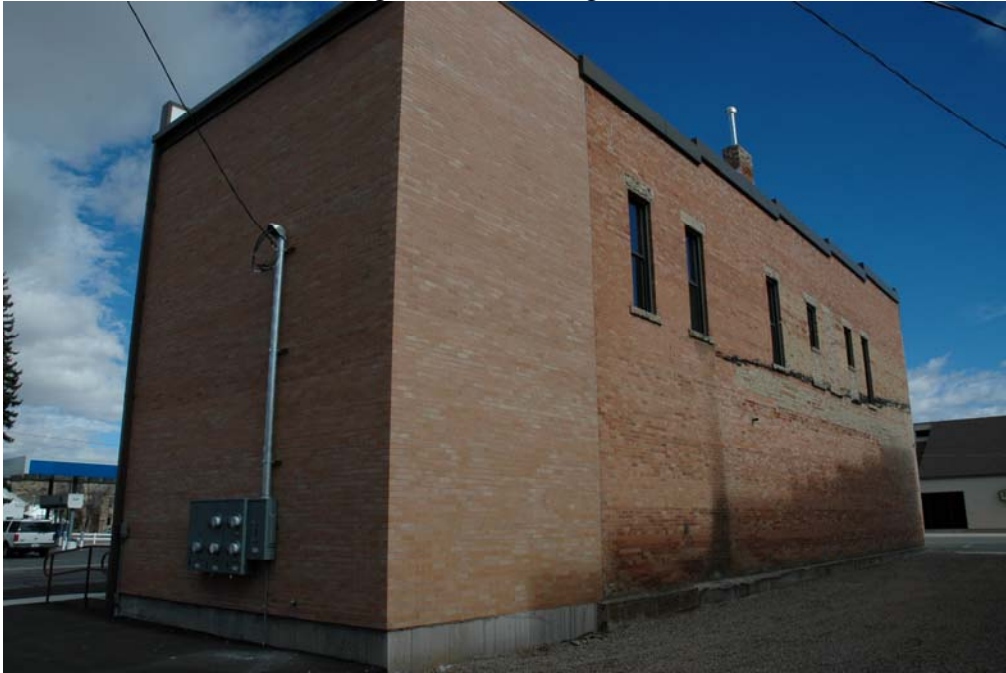
Photo No. 7:

6. South and west elevations of building. Camera facing northeast.

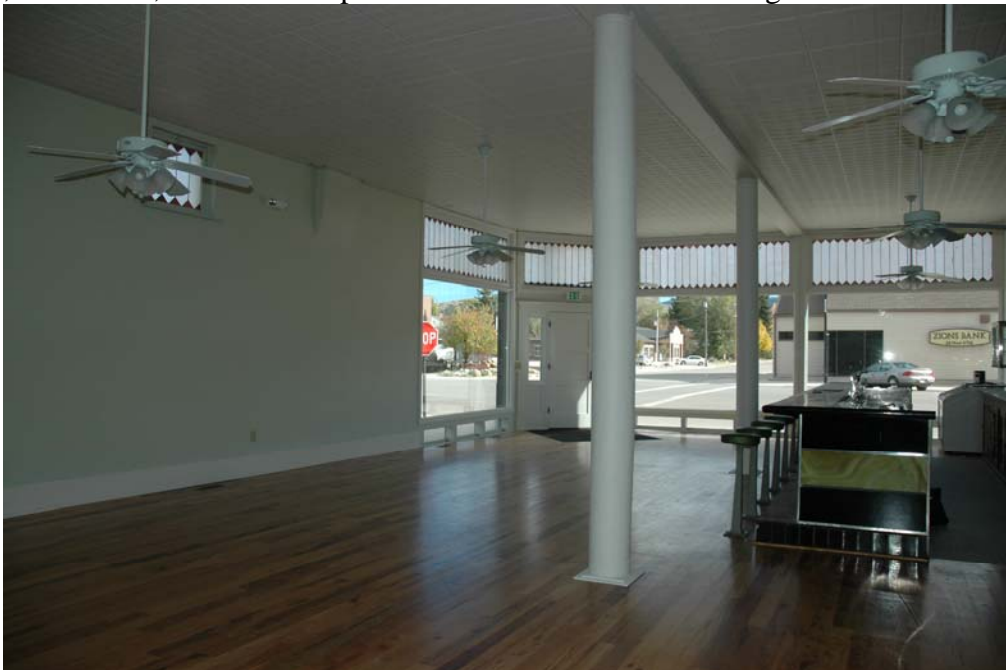
Photo No. 8:

6. Interior, main floor, commercial space and entrance. Camera facing northeast.

The storefront is the building's most prominent feature. The main entrance is angled and recessed behind a simple wood column. Originally the storefront consisted of an entrance with sidelights, large display windows, a transom row of leaded-glass windows, and a wood paneled base. In the 1960s, the storefront was updated with roman-brick facing, aluminum windows and door. The transom windows were first covered with signage in the 1940s. Using historic photographs, the current owner (a descendant of the original owner) recently restored the appearance of the original storefront and many features such as the transom glass, that were partially intact underneath later materials.
